Manhole Inspection Summary

Manhole # S03WW1003MH

Record Plat: **03WW1** Node: **003** Status: **Found**

Location Address: **3504 MENLO DR**

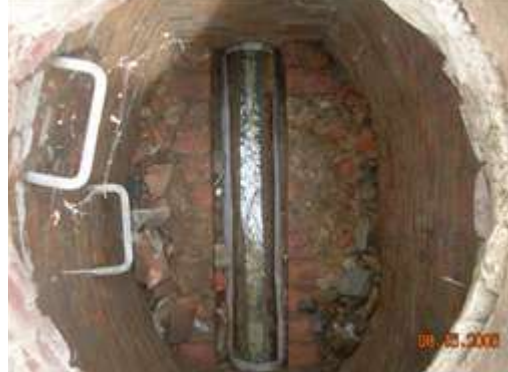
Top View

Frame leaks. Adjustment loose brick.
Adjustment, Corbel, and Barrel infiltration.
Bench debris.

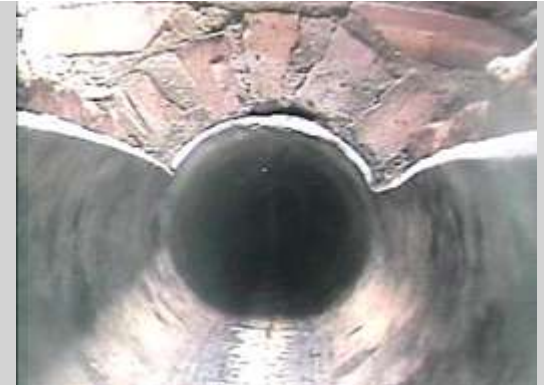
8 in. Circular Gravity Sewer Pipe Out @ 12 O'Clock

Comments **The I6 pipe picture shows Barrel deterioration and infiltration.**

Infiltration: **Evidence** Pipe Seal Cond: **Unknown**

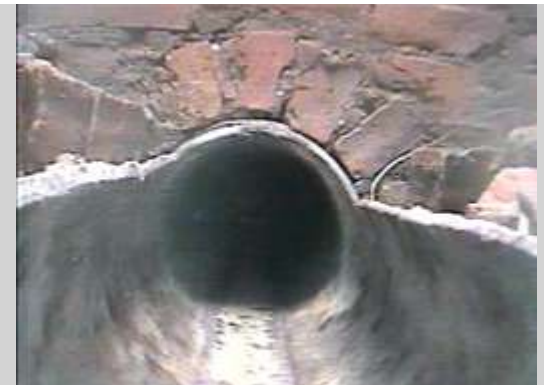
8 in. Circular Gravity Sewer Pipe In @ 6 O'Clock

Infiltration: **None** Pipe Seal Cond: **Cracked**
